GRACE grant no 679266

SmartBuoy technology and integration with oil spill detection networks

D1.3

WP1: Oil Spill detection, monitoring, fate and distribution

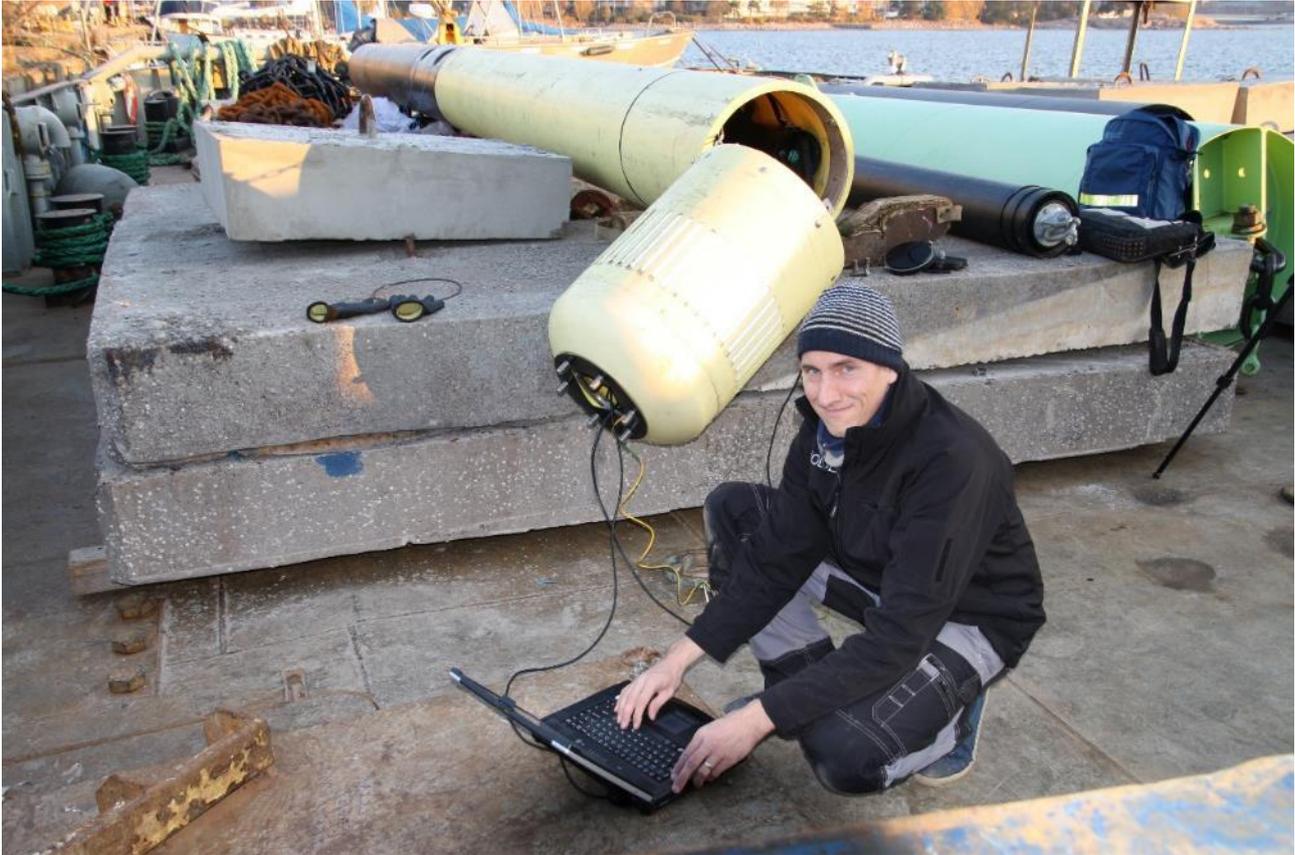
Figure 1. Testing of monitoring devices inside a SmartBuoy. Picture Seppo Virtanen / SeaHow

System integrations for automatic hydrocarbon monitoring buoy were completed for a GSM based data transmission system in October 2016. A new cleaning system to prevent bio-fouling was developed. System uses pressurised air burst to clean optical window of the fluorometer. System was laboratory tested and installed inside a SeaHow Smart Buoy and deployed in October 2016 for first wintertime trials.

Smart Buoy is a combination of robust polyethylene spar buoy and versatile selection of monitoring sensors with mobile communication technology (Fig. 1). Network of Smart Buoys enable intelligent solutions for many applications, like ENC, VTS, SAR, Ports etc.

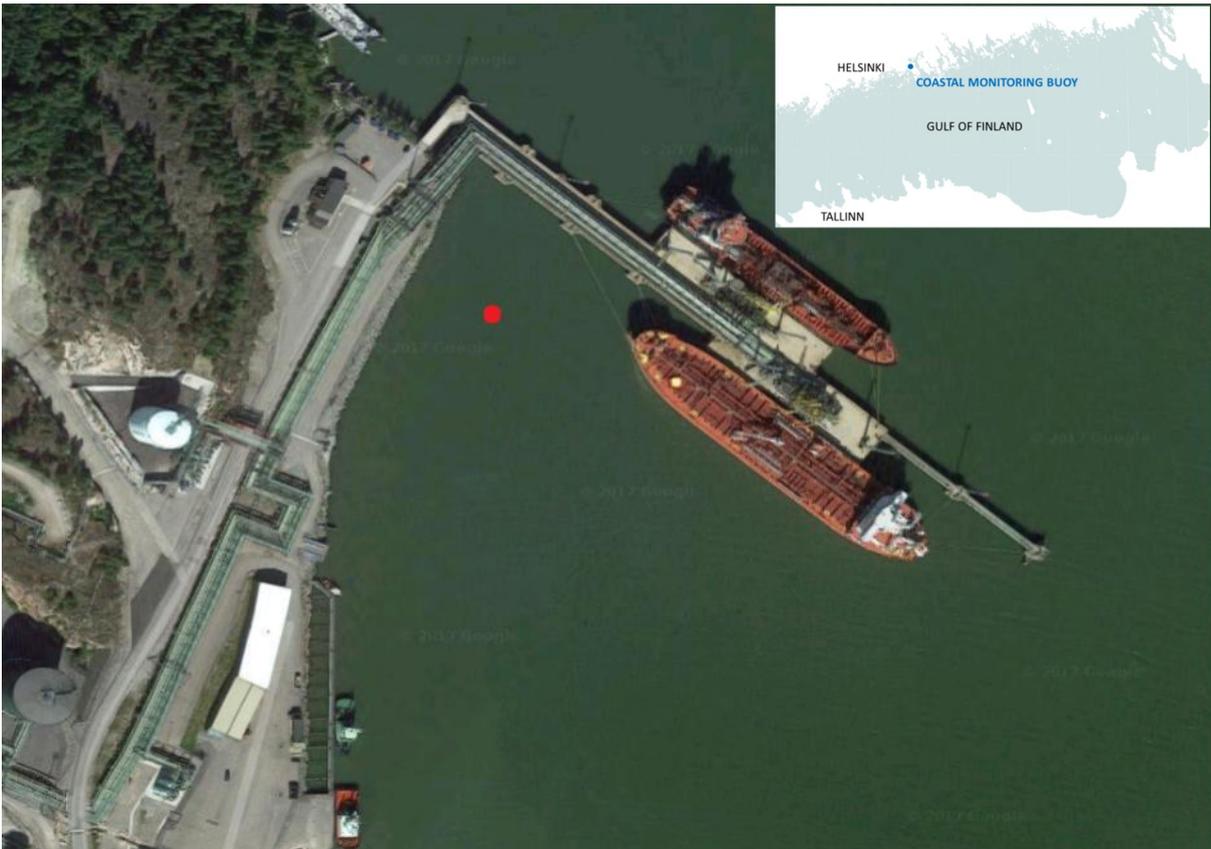
Figure 2. Monitoring location, Port of Neste Porvoo oil refinery. Picture Luode Consulting / MML.

Neste Porvoo Oli refinery harbour master and environmental specialists were contacted in order to have access to use sea area outside the refinery for sea trials. After site survey, a permission was granted for winter period 2016-2017. Suitable installation location to test winter tolerance of system was found right outside the seaport of refinery (Fig 2).

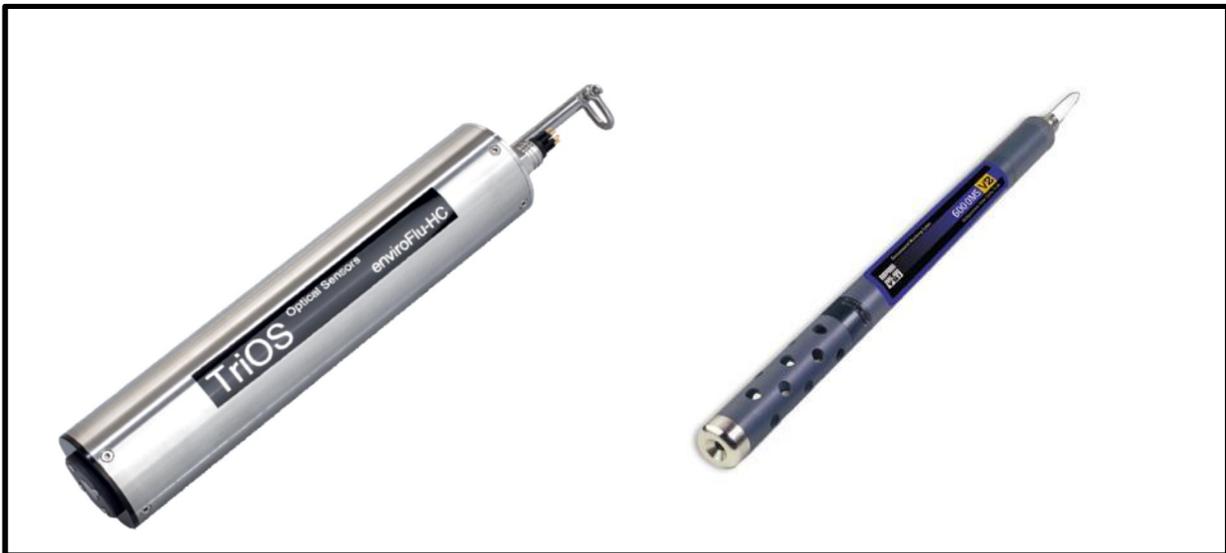
Figure 3. Left: Trios EnviroFlu hydrocarbon sensors and right: YSI 600 multiparameter sonde.

Sea trials are done with Trios EnrivoFlu hydrocarbon sensor which is installed together with YSI 600 series conductivity and temperature sensor (Fig 4). Sensors are placed inside of the buoy in a vertical monitoring well with open flow through pipe enabling continuous seawater exchange (Fig 4). Monitoring depth is 2.5 – 3.0m depending on current sea level. Hydrocarbon sensor detects total concentration of polyaromatic hydrocarbons suspended in seawater. In addition to hydrocarbon monitoring, salinity and temperature data is collected to verify the sensitivity of the system for changes in background signals as monitoring area is located close to river mouth.

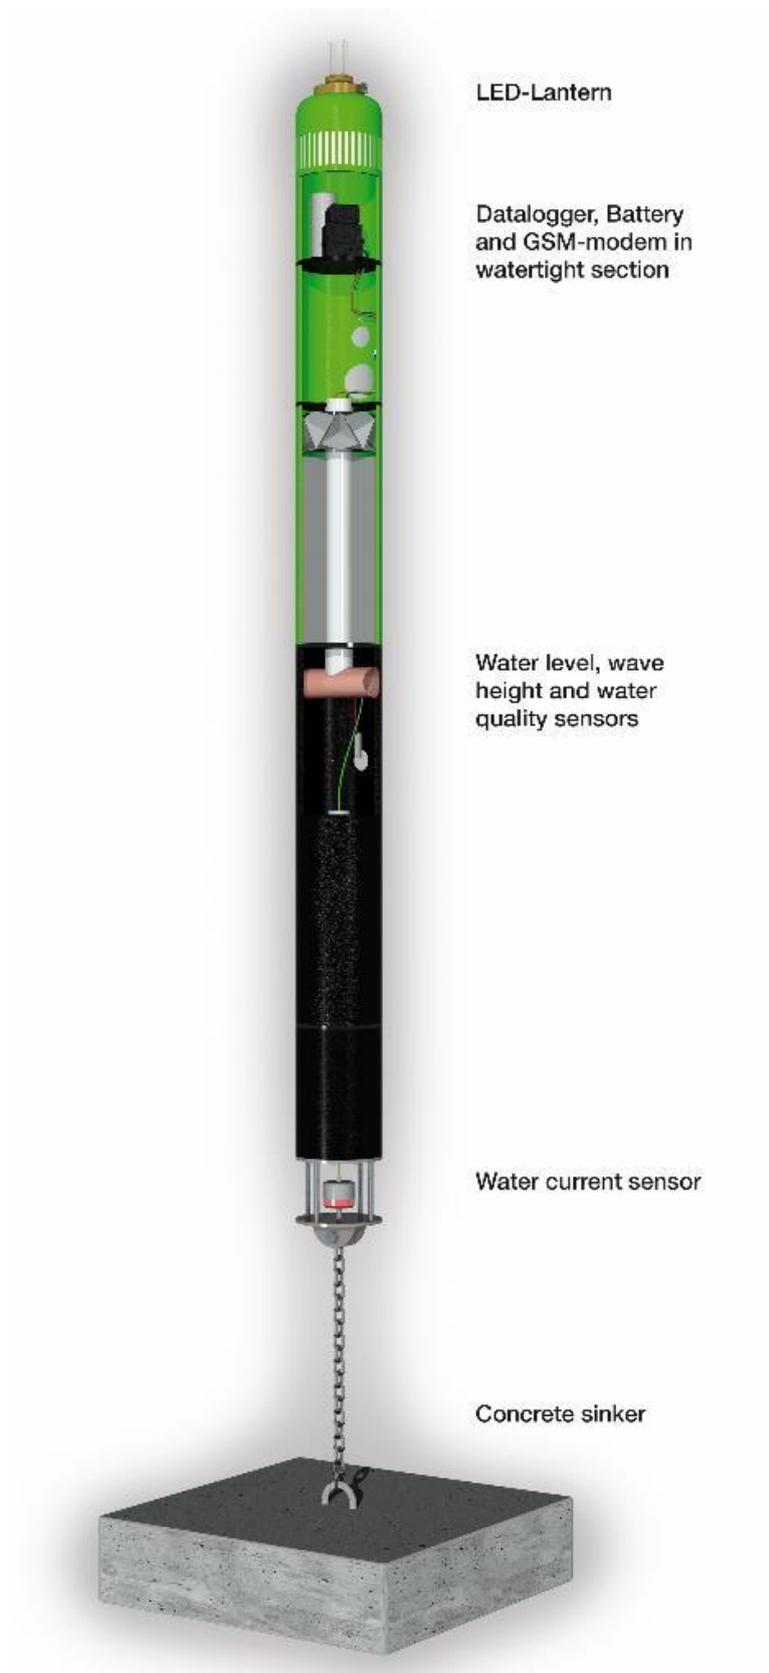
Figure 4. Schematic figure of SmartBuoy system. Sea trials utilizes water quality monitoring option, but the system can be used simultaneously also for water level, current and wave height monitoring.

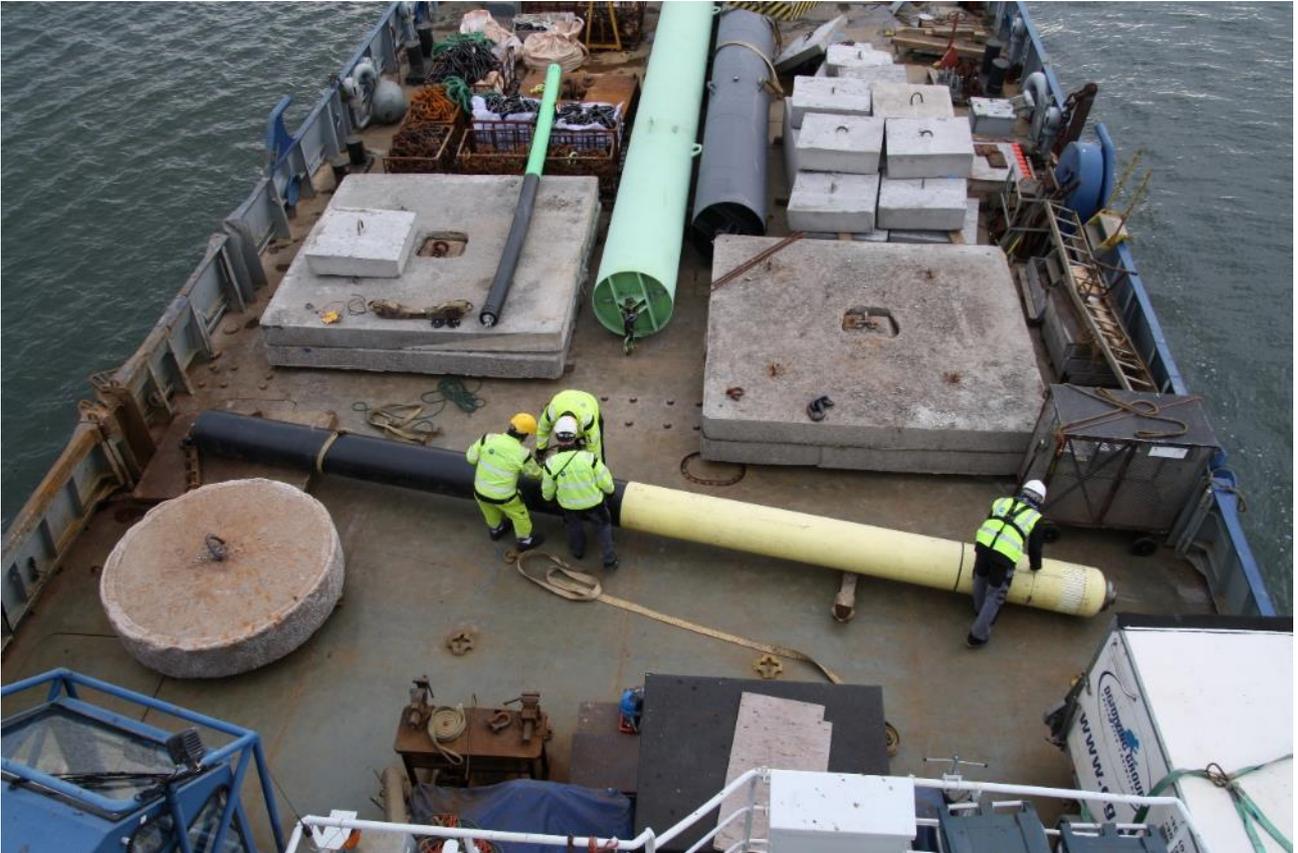
Figure 5. Preparation of moorings on board the buoy tender vessel "Seili". Picture Seppo Virtanen / SeaHow

SeaHow prepared moorings and installation of monitoring platform. System was installed on the 20th of October from vessel Seili (Fig 5). After installation laboratory samples were collected (Fig 6). The Smart Buoy has been visited two times until January 2017 for manual maintenance.

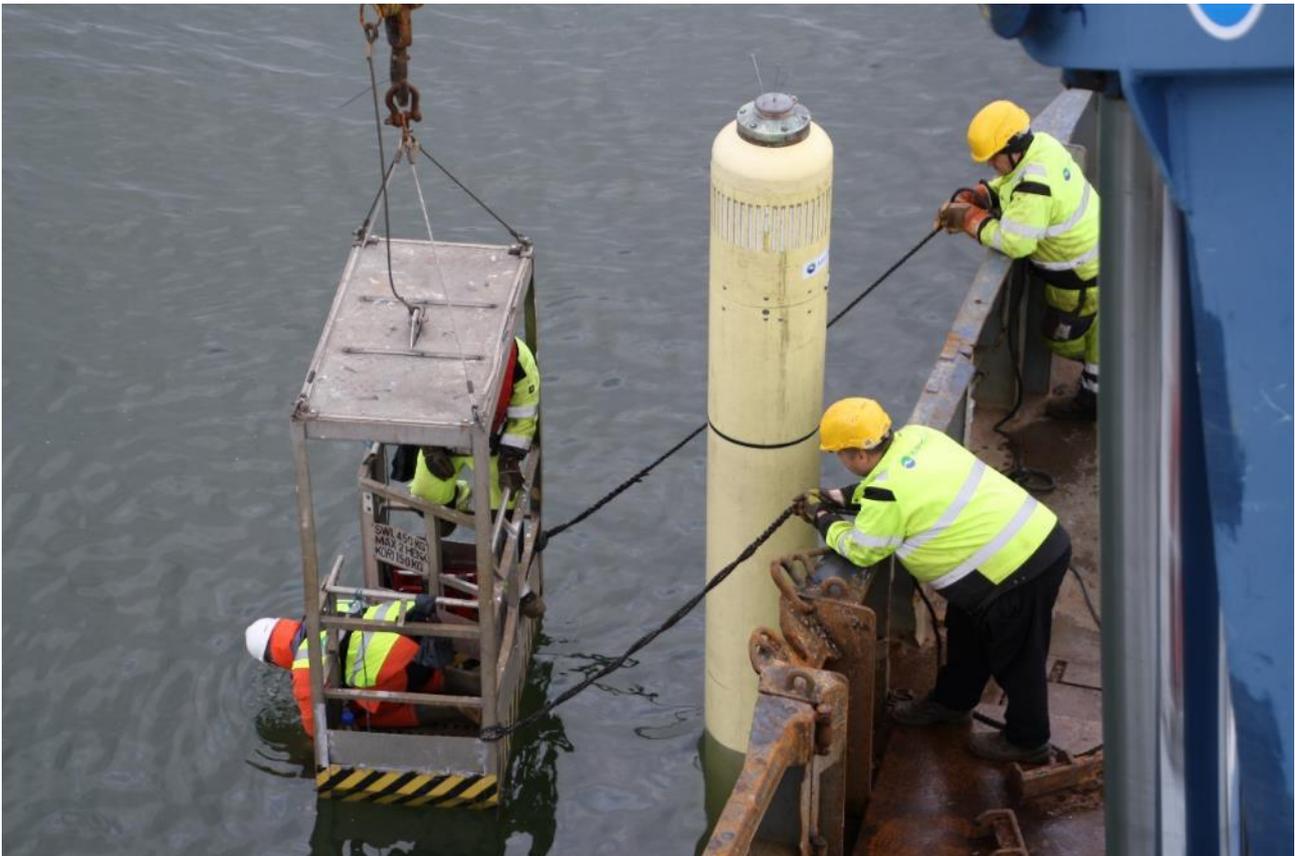
Figure 6. Water sampling for laboratory tests. Picture Seppo Virtanen / SeaHow

Seawater samples were collected from the deployment site for further laboratory analyses to be used in sensor calibration and data validation. Two parallel samples of surface seawater were collected for chemical laboratory analyses (PAHs) on October 20 2016, right after the buoy was deployed. Another set of samples for the chemical analyses (total oil, DOC and TOC) were collected at the buoy site (5–10 m away from the buoy; approximately 60°18.77' N, 25°33.21' E; Kilpilahti 1) at a depth of 1.5–2 m and from a pier (60°18.57' N, 25°33.15' E, about 350 m south of the buoy location; Kilpilahti 2) within the Neste Porvoo oil refinery's coastal waters on January 10, 2017. Two parallel water samples were collected from the two sites.

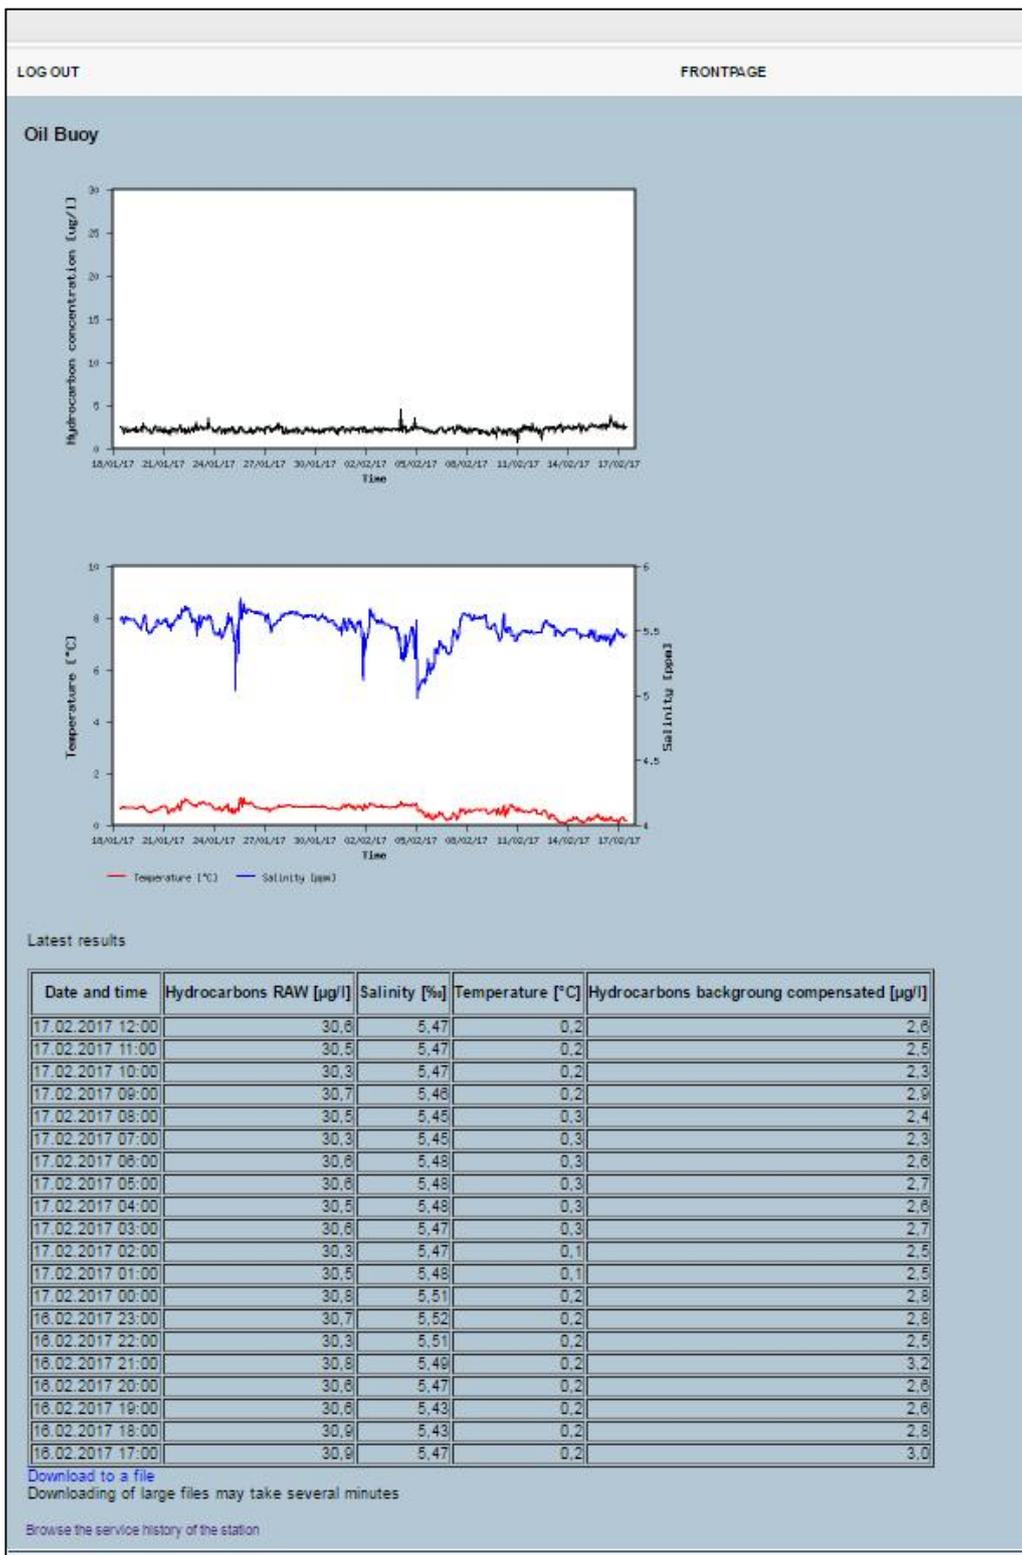
Figure 7. Screen capture from Luode on-line data service. Picture Luode Consulting Oy.

Data streaming from a SmartBuoy is done via Luode dataservice. Data quality check is done twice a day and data is presented thru password protected www-page (Fig 7). Until now over 2900 hourly hydrocarbon readings have been collected, together with additional 5800 salinity and temperature readings. Only one false reading out of 2900 has been flagged out from results. Floating debris or ice in front of the optical window can cause this kind of errors in measured signal.

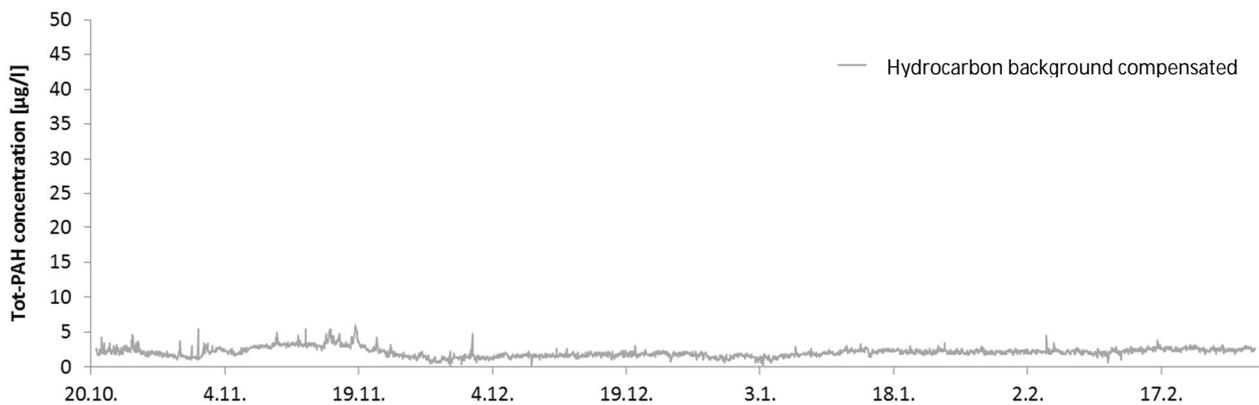
Figure 8. Collected hydrocarbon data processed with initial calibration. The data will be re-calibrated when more reference data is available.

Based on the collected hydrocarbon concentration data, values remained more or less constant and no sign of oil contamination was detected. General level of the collected total hydrocarbon data (Fig. 8) was anyway above the level detected with the laboratory analyses (Table 1). River flows and runoff from land areas are carrying organic carbon (Table 2. DOC&TOC) and turbidity to coastal sea areas which have an impact on fluorescence in hydrocarbon detection. The impact of these interference parameters can be eliminated in sensor calibration when more reference data is available.

No sign of oil contamination was detected, but the results show that hydrocarbon detection with fluorometers in coastal sea areas requires local calibration and understanding the impact of interference parameters such as organic carbon and turbidity.
